COTTONWOOD CREEK DOUG JOHNSON PROJECT:

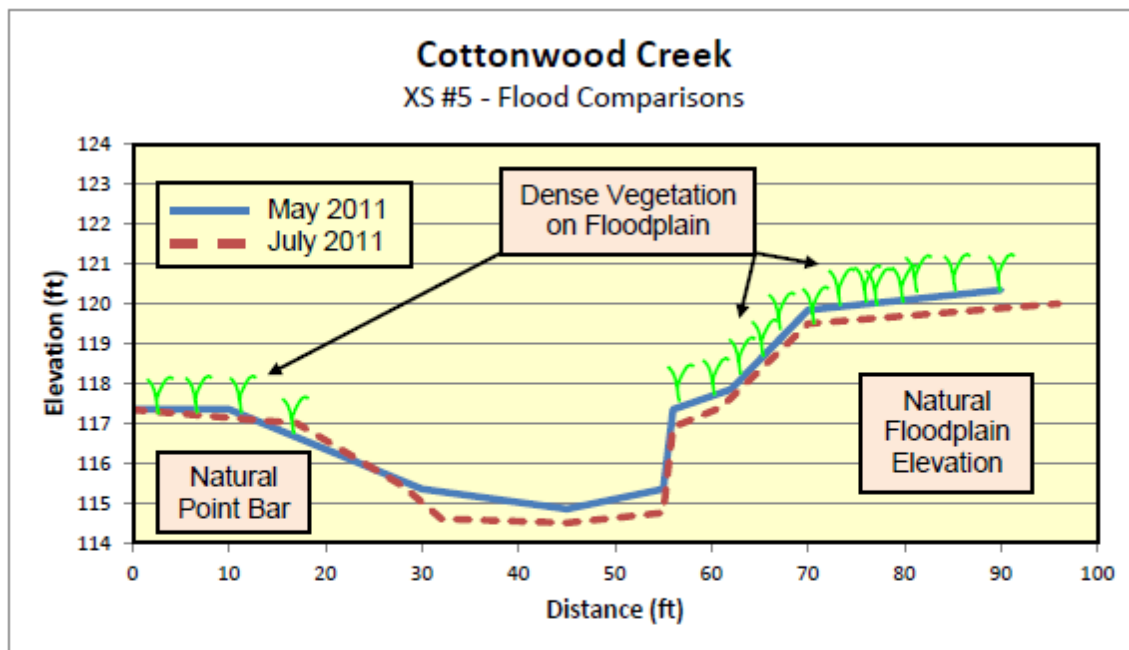
On June 8, 2011, a flood estimated at over 1100 cfs (over 50-year event) passed through the project area. The design team had done x-section surveys prior to this time, and was able to return and re-survey to determine the nature of the channel changes caused by this flood. One short reach of the channel on the property (as well as many well-vegetated, undisturbed reaches upstream) did not change perceptibly despite the magnitude of this flood. This stable reach was relatively well-vegetated and had a broad accessible, vegetated floodplain. This reach was one indicator of “reference” characteristics for channel and floodplain.

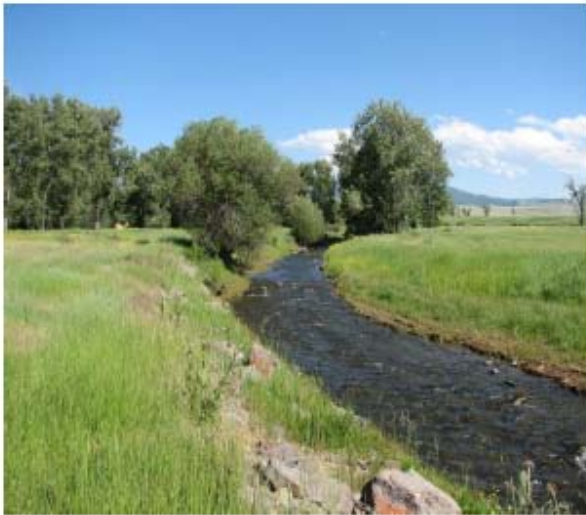
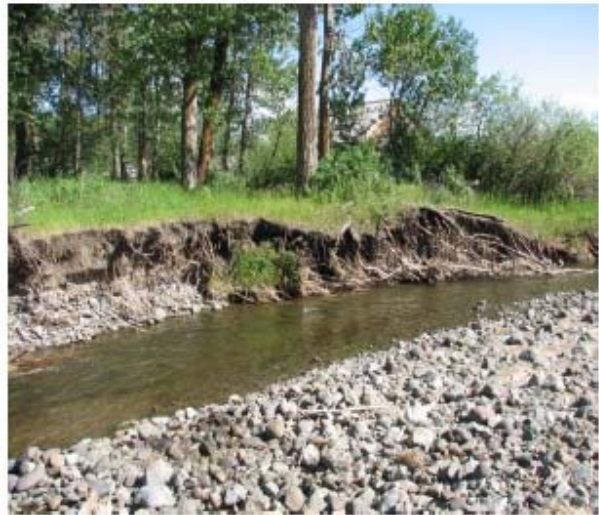
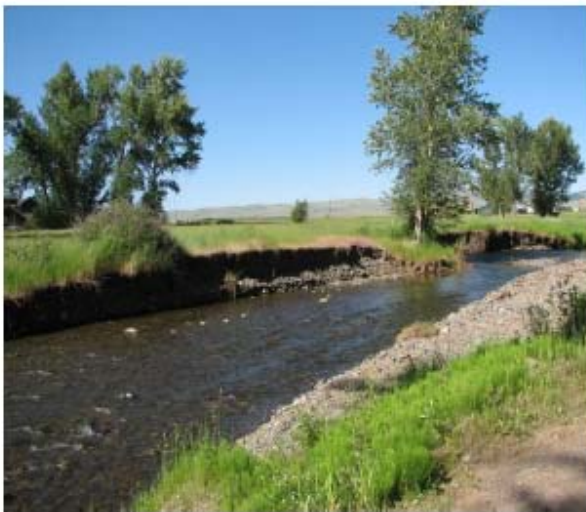
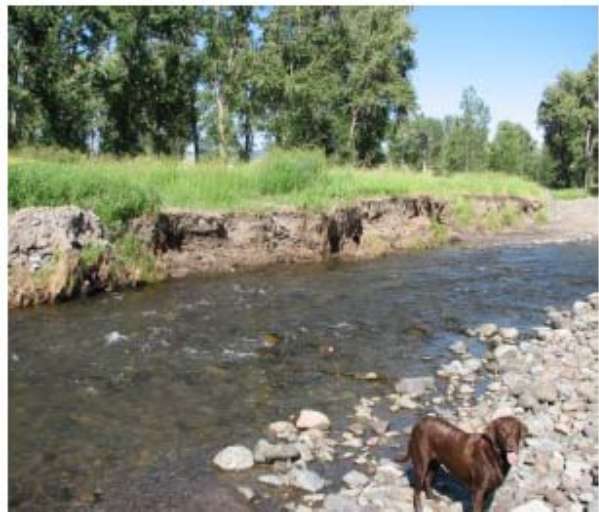
Figures 4 - 7. These pictures of the Cottonwood Creek project site show channelized stream reaches, eroding streambanks, poor habitat conditions, and a lack woody understory vegetation throughout the riparian corridor due to historic over-grazing.
